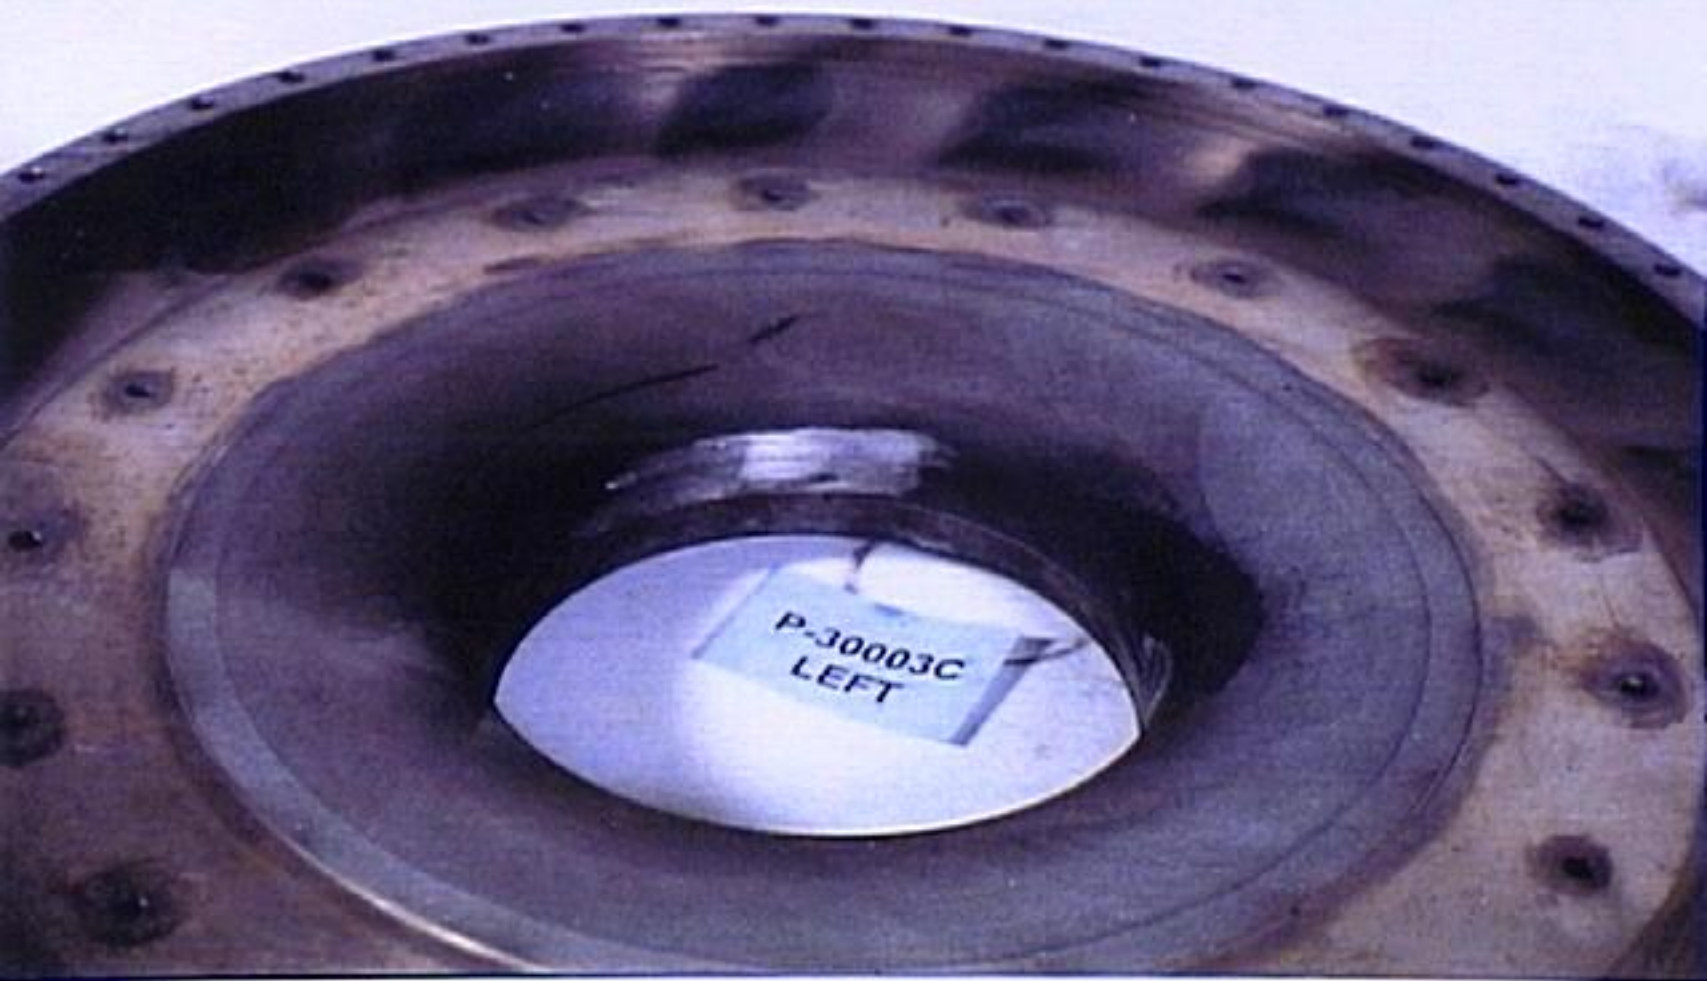
**Figure 27. Contour Rub on Second Stage Impeller Shroud**
